Automatic Detection of High Temperature Hydrogen Attack Defects from Ultrasonic A-scan Signals.

Ahmed Yamani, Mohamed Deriche

King Fahd University of Petroleum and Minerals,
Dhahran, Saudi Arabia

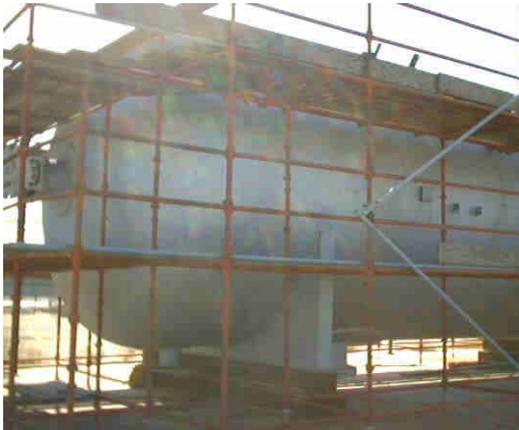
An out-of-service pressure vessel shown in Figure 1, with wall thickness 33 mm known to have many HTHA is used to collect RF A-scan signals for use in the Database. The data acquisition system consists of a SONATEST Masterscan 340 flaw detector, compression wave probes, couplant, and calibration blocks. The flaw detector has the capability of displaying and storing up to 100 RF A-scan signals. It also can transfer these signal to a PC via an RS 232 interface using the SONATEST Data Management Software (SDMS). A schematic of this data acquisition system is shown in Figure 2.

Figure 1: An out-of-service pressure vessel

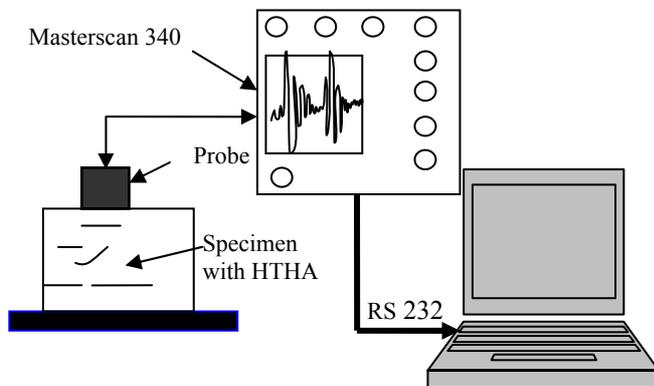
Figure 2: Data acquisition system used

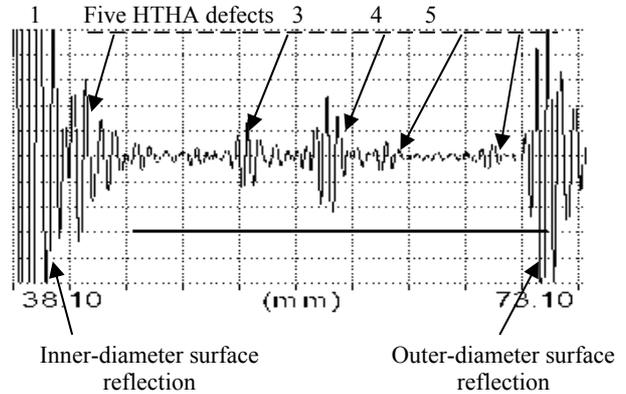
After calibrating the flaw detector, the probe is placed on the outer wall of the 33 mm pressure vessel. A snapshot of the flaw detector screen is shown in Figure 3, where 5 HTHA defects are shown to be located within the pressure vessel wall thickness. The time-base of the flaw detector is zoomed to the region of defect 5 to isolate its A-scan signal from the rest of the defects. The result is shown in Figure 4.

Figure 3: Snapshot of the flaw detector screen showing 5 HTHA defects located along the wall thickness.

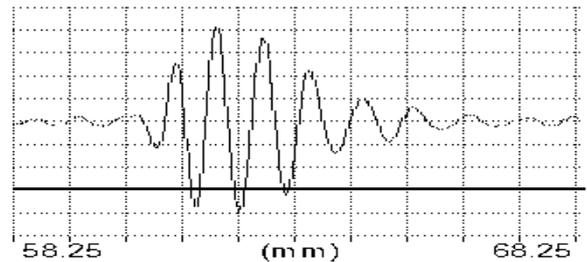
Figure 4: A snapshot of the flaw detector screen showing one HTHA defect

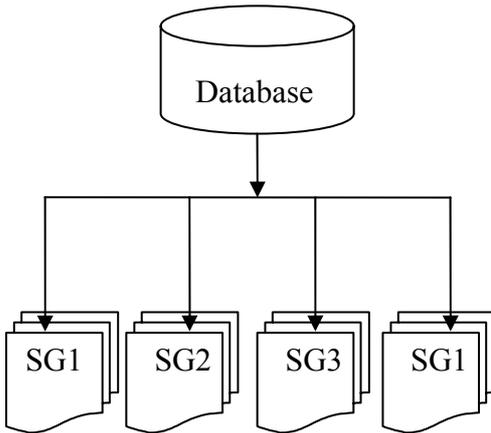
The databases are organized in 4 sub-groups containing 100 A-scans each as shown in Fig.5.

Figure 5: Organization of each database in 4 sub-groups of 100 scans each.

The AUDC system is first trained using 20 sets of A-scan for each class, and then tested by a set of 10 A-scans. The training sets are therefore picked randomly from each sub-group (from 100 A-scans), whereas, the testing sets are picked randomly from the remaining 80 A-scans of the same sub-group. This results in approximately 1.6×10^{12} independent possible tests. The AUDC system is tested 500 times and the worst classification result is shown in the confusion matrix shown in Table I below.

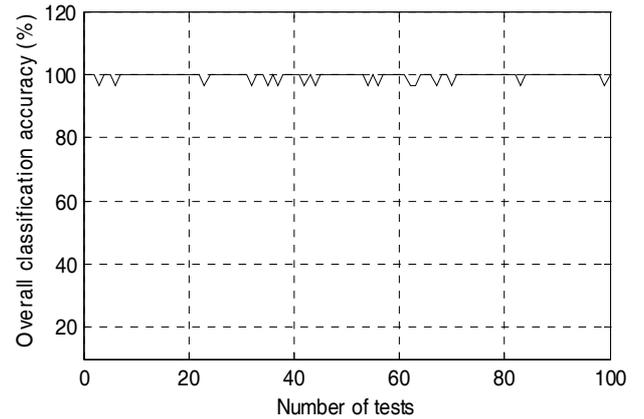
Figure 6: Overall classification accuracy for the three defects (average 99.46%).

The overall classification accuracy (average of the diagonal elements of the confusion matrix) is not affected much when the system is subjected to different tests. For 100 independent tests, the overall classification accuracy is shown in Figure 6. The average over these tests is 99.46%. For HHTA defect, the classification accuracy versus the number of tests is shown in Figure 7, which averages to 98.4%.

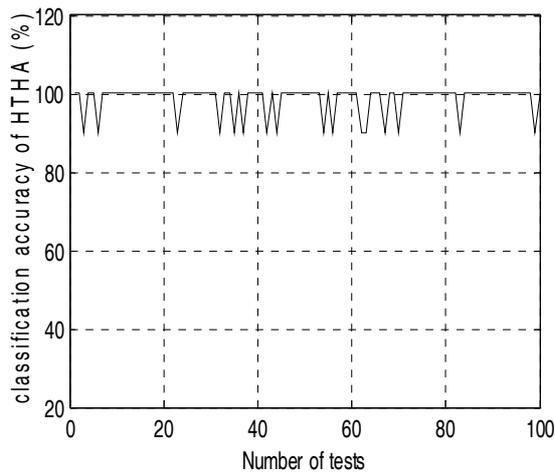
Figure 7: classification accuracy for the HTHA (average=98.4%).
